Region 3 GPRA Baseline RCRA Corrective Action Facility

Tyco Electronics (AMP Inc.)

Current Progress at the Site

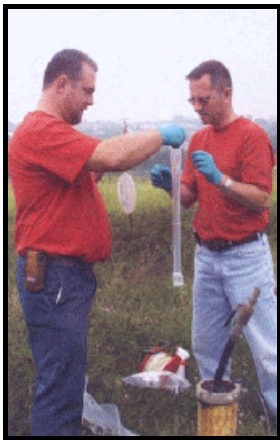
Figure 1: A stainless steel wire is attached to the diffusion bag and lowered into the well.

The facility is currently testing a new method for acquiring groundwater samples called diffusion sampling. Diffusion sampling is a relatively new technology designed to use passive sampling techniques that eliminate the need for well purging. A diffusive-membrane capsule is filled with deionized distilled water, sealed, mounted in a suspension device, and lowered to a specified depth in a monitoring well. Over time the VOCs in the groundwater diffuse across the capsule membrane, and contaminant concentrations in the water inside the sampler attain equilibrium with the ambient groundwater. The diffusion bag sampler is subsequently removed from the well, and the water within the sampler is transferred to a sample container and submitted for analysis. The facility will test this method for several quarters and will compare the results from the diffusion bag to historical data. If the results are similar, this method may be used for future groundwater monitoring. Below are pictures taken during the deployment and retrieval of the diffusion bags.

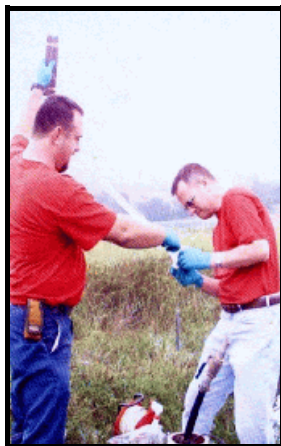
Figure 2: A weight is attached to the bottom of the bag to stabilize the deployment of the bag.

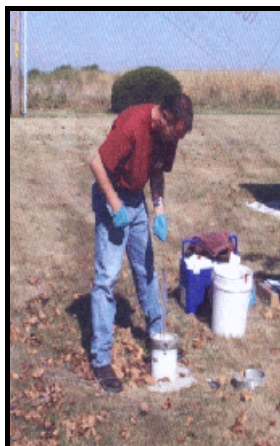
Figure 3: Retrieving the diffusion bag from the well.
